MICHIGAN DEPARTMENT OF ENVIRONMENT, GREAT LAKES, AND ENERGY
WATER RESOURCES DIVISION
JUNE 2022

STAFF REPORT

BIOLOGICAL AND SEDIMENT CHEMISTRY SURVEYS OF SELECTED
LOWER GRAND RIVER WATERSHED STREAMS
IONIA, KENT, MONTCALM, MUSKEGON, AND OTTAWA COUNTIES, MICHIGAN
AUGUST-SEPTEMBER 2019

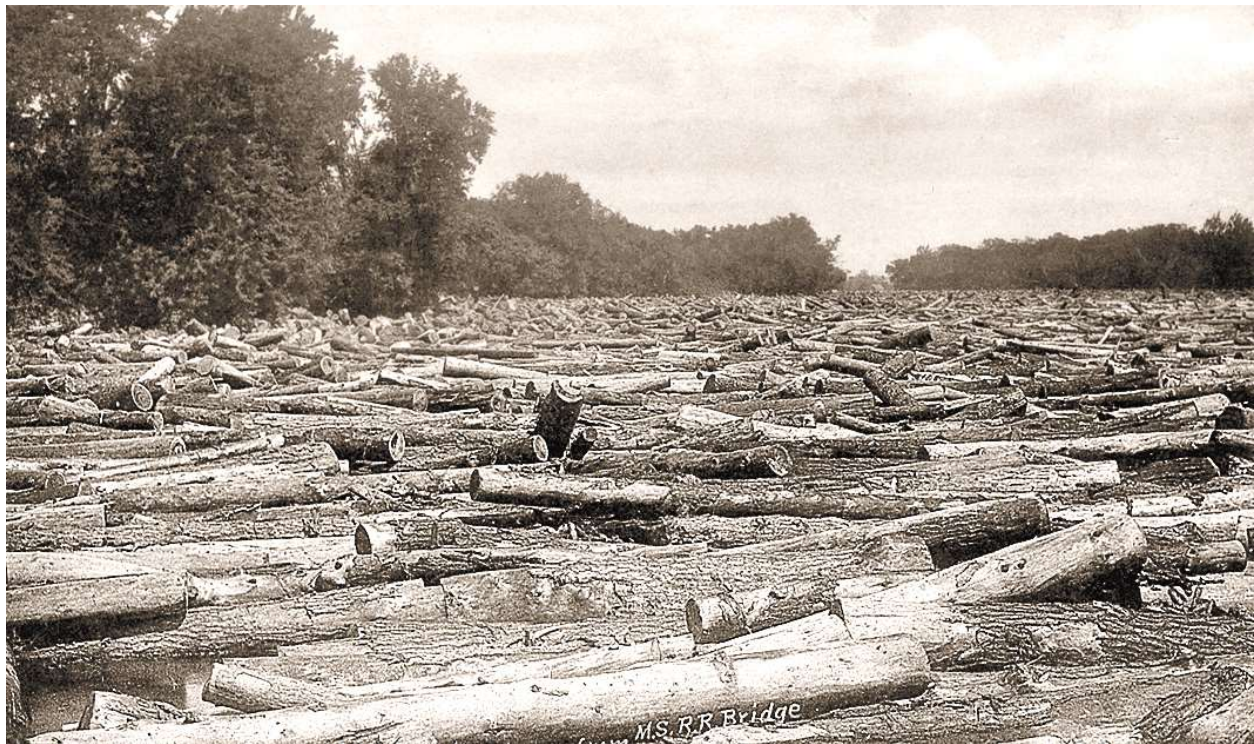
Figure 2. Portion of massive log jam in Grand River that occurred in 1883. Photo from http://blog.mlive.com/chronicle/2008/07/grand_jam_of_1883.html.

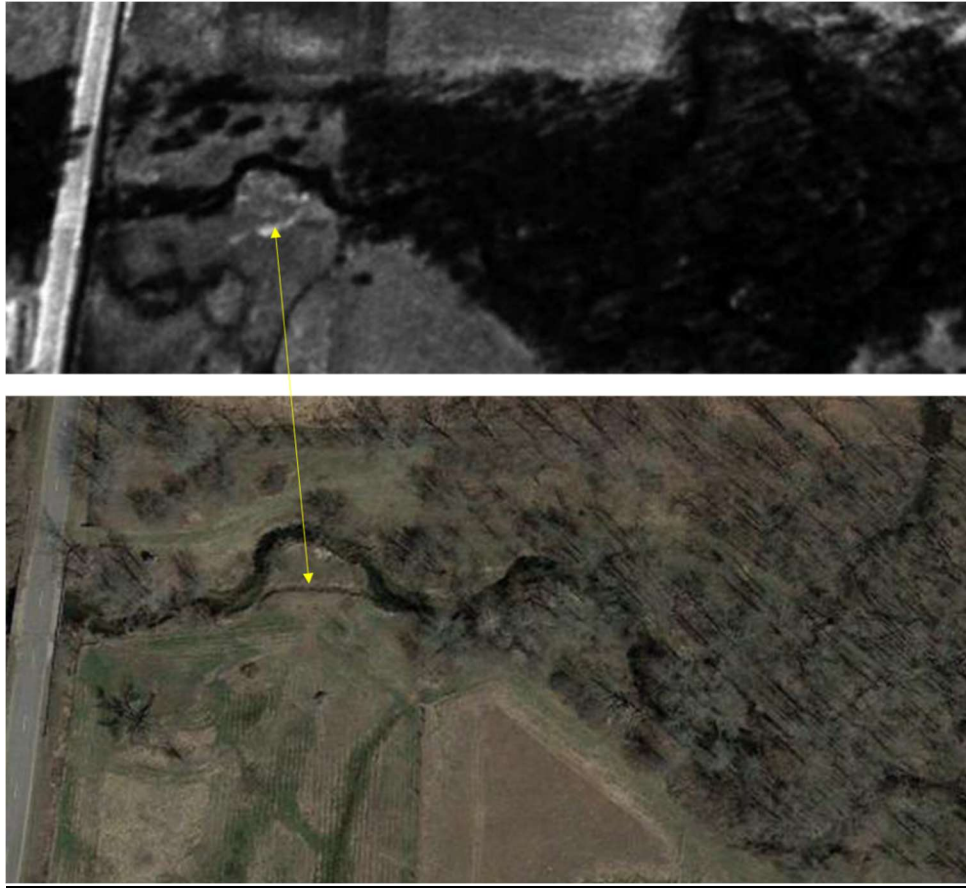
Sand was the dominant substrate (55 percent visual estimate) and some gravel and cobble was also present. The cobble was in the stream largely because some rip rap had been placed on some of the banks for stabilization. A small channel also appears to have been dug through a bank. This may have been done in an attempt to reduce flow from eroding a steep bank on the right side of the stream. In 2009, the macroinvertebrate community at this site scored poor and Rippke (2011) noted that dredging had recently occurred at this site. It is possible that Rippke (2011) had surveyed this site shortly after the channel was dug, which may have impacted macroinvertebrate communities. North Branch Crockery Creek is not a county drain and no permits were found in MiWaters for a channelization project at that site, so proper oversight may have been lacking. Overhanging vegetation, rootwads, and large woody debris were moderately available as habitat but undercut banks and macrophytes were sparse. The stream banks showed evidence of flashiness with scour greater than 20 inches above the water surface and storm debris observed in trees about 5 feet above the water surface. Despite some bank stabilization efforts, most of the banks were actively eroding. Along the left bank appeared to be a grazing pasture and along the right bank was a row crop. Large trees are along the immediate bank, which provide some canopy cover. The macroinvertebrate community appears to be improving since receiving a poor score in 2009, but habitat remains stable (Table 4).

Figure 3. Aerial photos of North Branch Crockery Creek upstream of 24th Avenue. Top photo is from 1997 and bottom photo is from 2011.

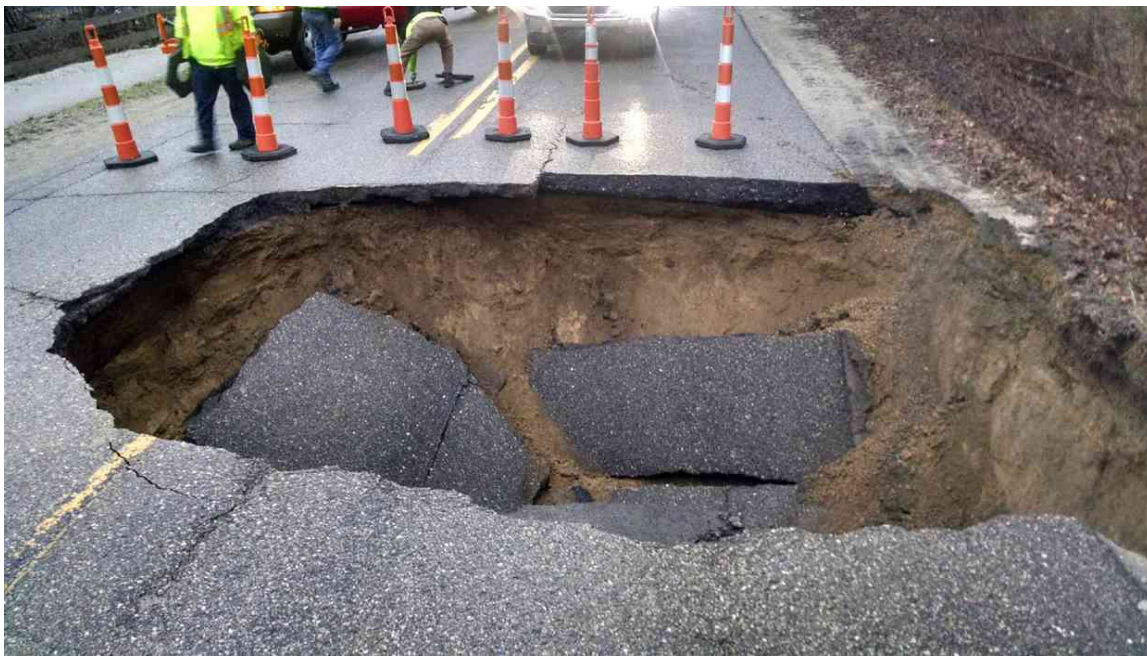
On March 1, 2017, during a heavy rainstorm, a culvert failure occurred on 148th Avenue in Spring Lake Township. The culvert failure occurred when a hole developed in the middle of a 30-inch diameter pipe under about 17-18 feet of soil. Soil from the road berm washed out and eventually caused the pavement to collapse on 148th Avenue (Figure 7), causing large amounts of sediment to enter an unnamed tributary to Lloyds Bayou (Figure 8). A new, 36-inch diameter culvert has since been installed. Every year, culvert failures occur in the state, particularly in the spring, during large rain events. This stream was sampled in 2017 and again in 2019 to evaluate habitat and macroinvertebrate communities immediately after a culvert failure and in subsequent years.

Figure 7. Collapsed section of 148th Avenue in Spring Lake Township after a culvert failure. Image from Grand Haven Tribune online article (link no longer available).

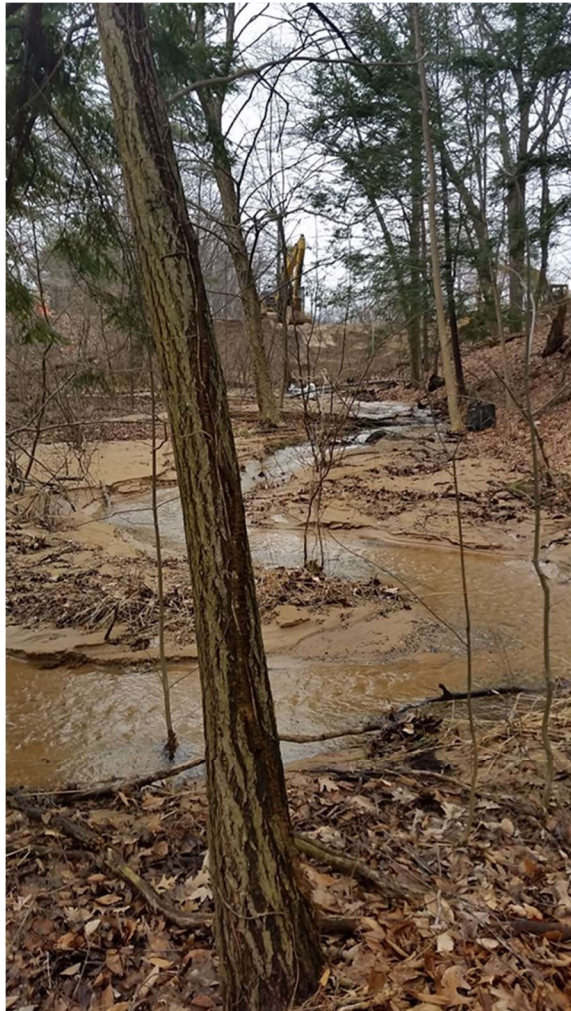
A similar macroinvertebrate community was found at that site in 2017, four months after the culvert failure. In 2017 much of the stream bank was covered with bare sand from the berm, which lowered the habitat score at the time (116 [good]; Figure 8). During the 2019 visit, vegetation was growing along the banks and stabilizing the soils (Figures 8 and 9).

Figure 8. Before and after photos of stream banks below 148th Avenue. Photographs on left were taken in March 2017, shortly after the culvert failure. Photos on the right were taken in May 2020.

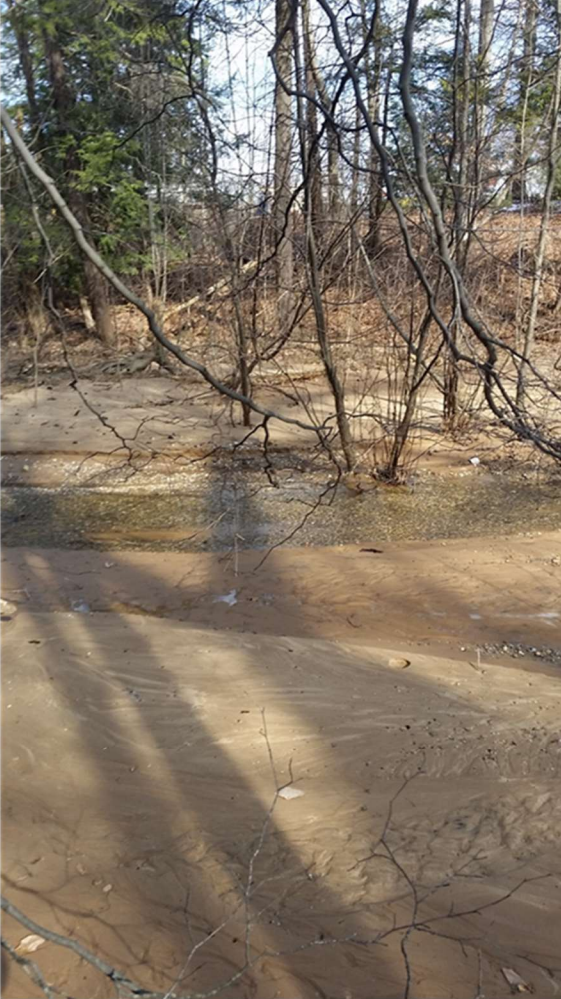
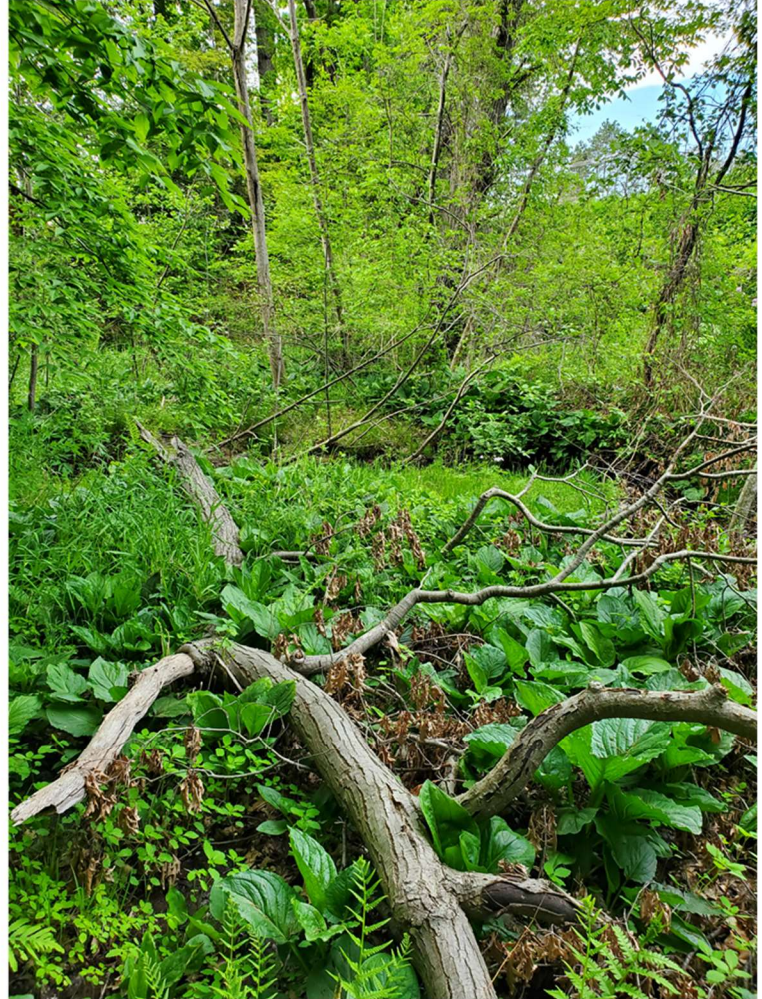
Figure 9. Before and after photos of stream banks below 148th Avenue. Photographs on left were taken in March 2017, shortly after the culvert failure. Photos on the right were taken in May 2020.

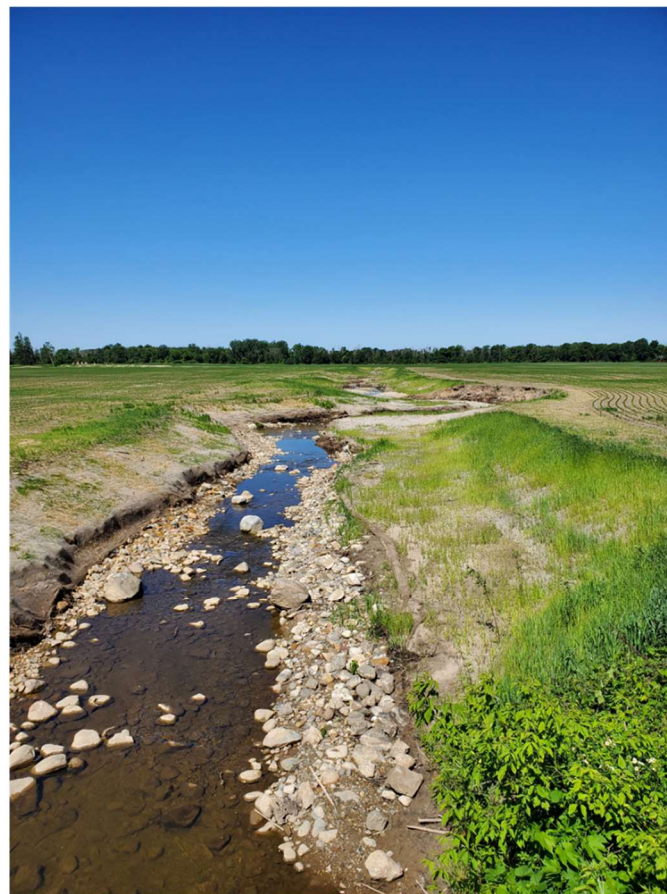
Slightly downstream from 32nd Avenue, Sand Creek was sampled above Wilson Street. This site was sampled prior to the implementation of extensive lengths of two-stage ditches (Figure 10) and upland stabilization. The macroinvertebrate community at Wilson Street scored low acceptable (-2; Appendix 2) and habitat scored marginal (83; Appendix 1). Seventeen taxa were collected, of which, only 3 were EPT, indicating poor habitat and/or water quality. The taxa were dominated by a mix of Chironomidae, Isopoda, and Calopterygidae, all of which tend to dominate in stressed systems (Voshell, 2002). All habitat types such as large woody debris and undercut banks were either sparse or absent. The substrate was an even mixture of clay, silt, sand, and gravel. The stream banks showed signs of flashiness with scour greater than 18 inches above the water surface, storm debris was observed in tree branches about 7 feet above baseflow, and banks were actively eroding. The stream at baseflow was also not

occupying the entire channel and several sediment bars were present. The riparian vegetation was diminished by row crops on both sides of the stream.

Figure 10. Two-stage ditch banks at Wilson Street site (left photo) and slightly upstream (right photo) in June 2020.
